Re: Notice of Violation
RCRA Compliance Evaluation Inspection – Herr Voss Stamco
EPA ID No.: INR 000 105 213

COMPLIANCE EVALUATION INSPECTION REPORT

INSTALLATION NAME: Herr Voss Stamco RCI, Inc.
U.S. EPA ID. No.: INR 000 105 213
LOCATION ADDRESS: 1079 Industry Drive Lot 1
Chesterton, Indiana 46304
DATE OF INSPECTION: November 16, 2015
U.S. EPA INSPECTORS: Sheila Burrus, RCRA Hazardous Waste

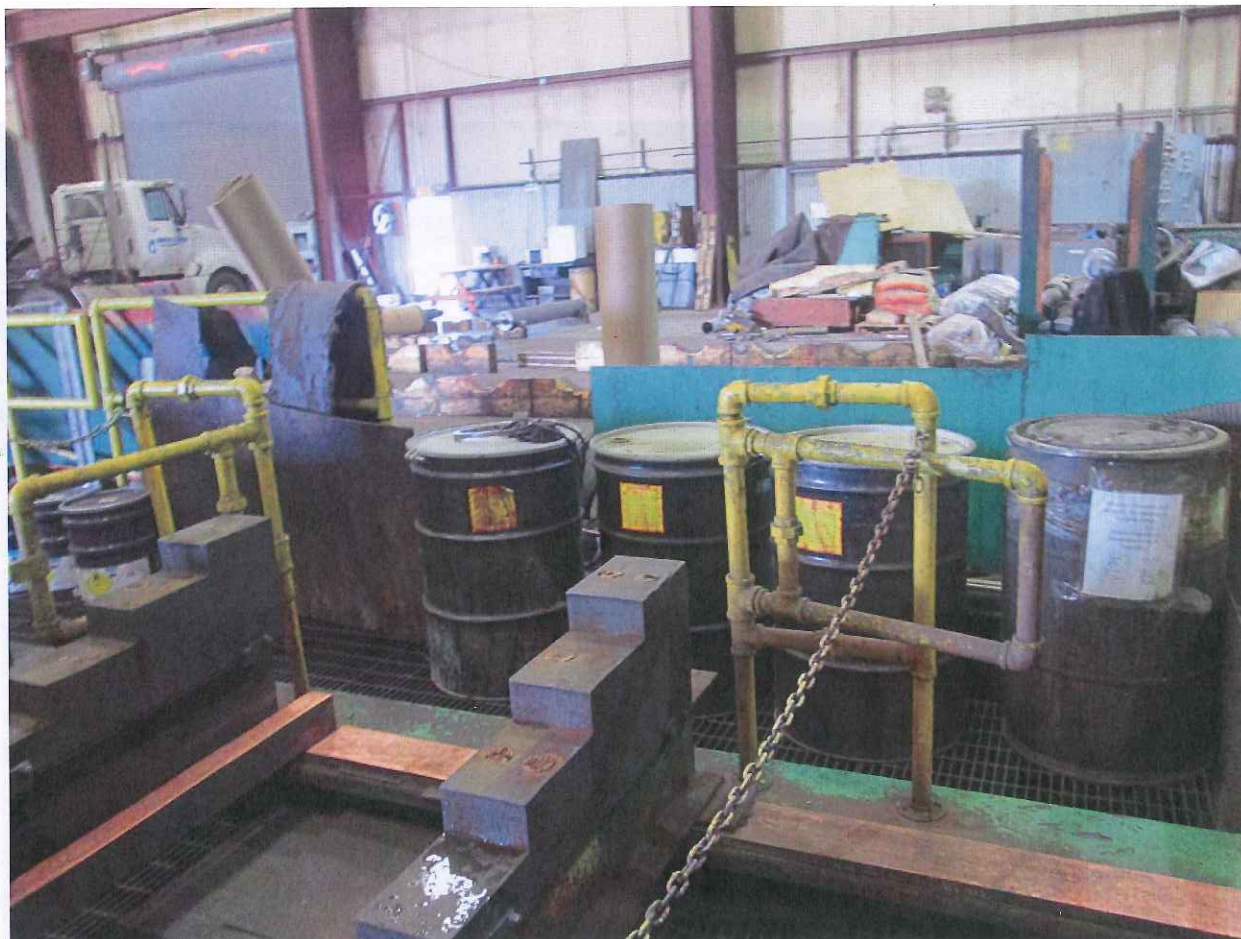
PHOTOGRAPH: 1

At the time of the inspection, Herr Voss Stamco maintained one 55-gallon container of hazardous waste solids that was not marked with the date upon which the period of accumulation of hazardous waste began in the less than 90-day hazardous waste storage area.

- There were three 55-gallon containers of hazardous waste solids (chromium rags, bags and debris) located in the less than 90-day hazardous waste storage area. All three containers had hazardous waste labels with descriptions of the contents but only two of the containers were dated. One container had a date of 9/22/2015 and the other container was dated 11/16/2015. I asked Ms. Brannon about the undated container. Ms. Brannon stated that she was unaware that the container was not dated due to the positioning of the drum when she conducted her last inspection on 11/10/15. Ms. Brannon said that she could see the hazardous waste label on the container but not the information on the label. Ms. Brannon said based on her records and discussion with staff, the drum filled date for the unlabeled container should have been 10/18/15. The container was back dated 10/18/15 (Photograph 1).

Chrome Plating Area/90-day H.W. Storage Area

three closed/labeled 55-gallon containers of hazardous waste solids...one container without a date

During the inspection, as observed by EPA, and after the inspection, as documented in November 18 and 19, 2015 emails to EPA, you took certain actions to establish compliance with the above contingency plan and accumulation time requirements. Based on that information, EPA is not planning additional enforcement action at this time. This letter does not limit the applicability of the requirements evaluated, or of other federal or state statutes or regulations. EPA appreciates Herr Voss Stamco's cooperation.

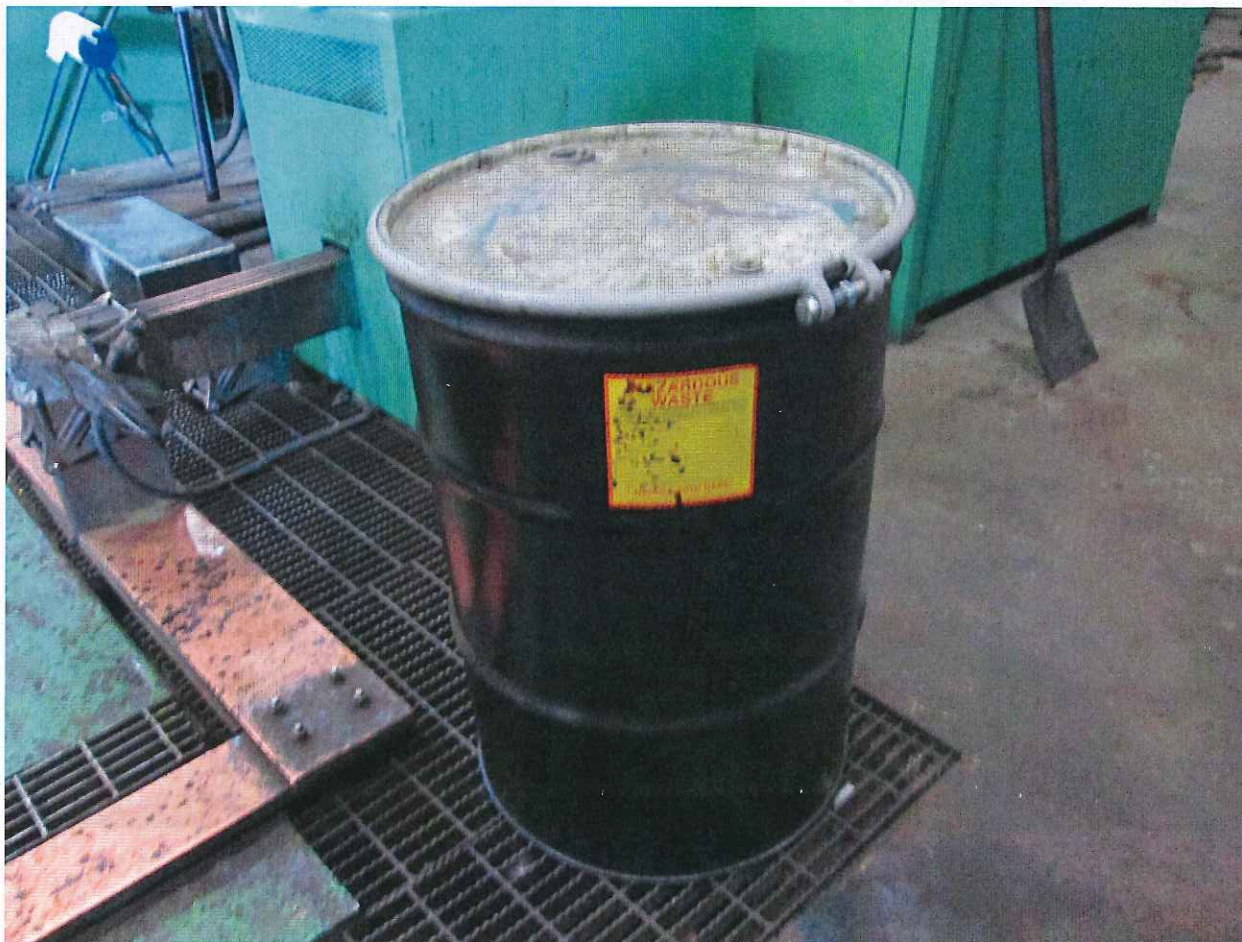
PHOTOGRAPH: 2

- There was one closed/labeled 55-gallon satellite accumulation container of chrome waste located at the chrome plating line (Photograph 2).
- There was a labeled 300 gallon used oil tank located in the truck bay area.

Chrome Plating Area

closed/labeled 55-gallon satellite accumulation container
of hazardous waste solids

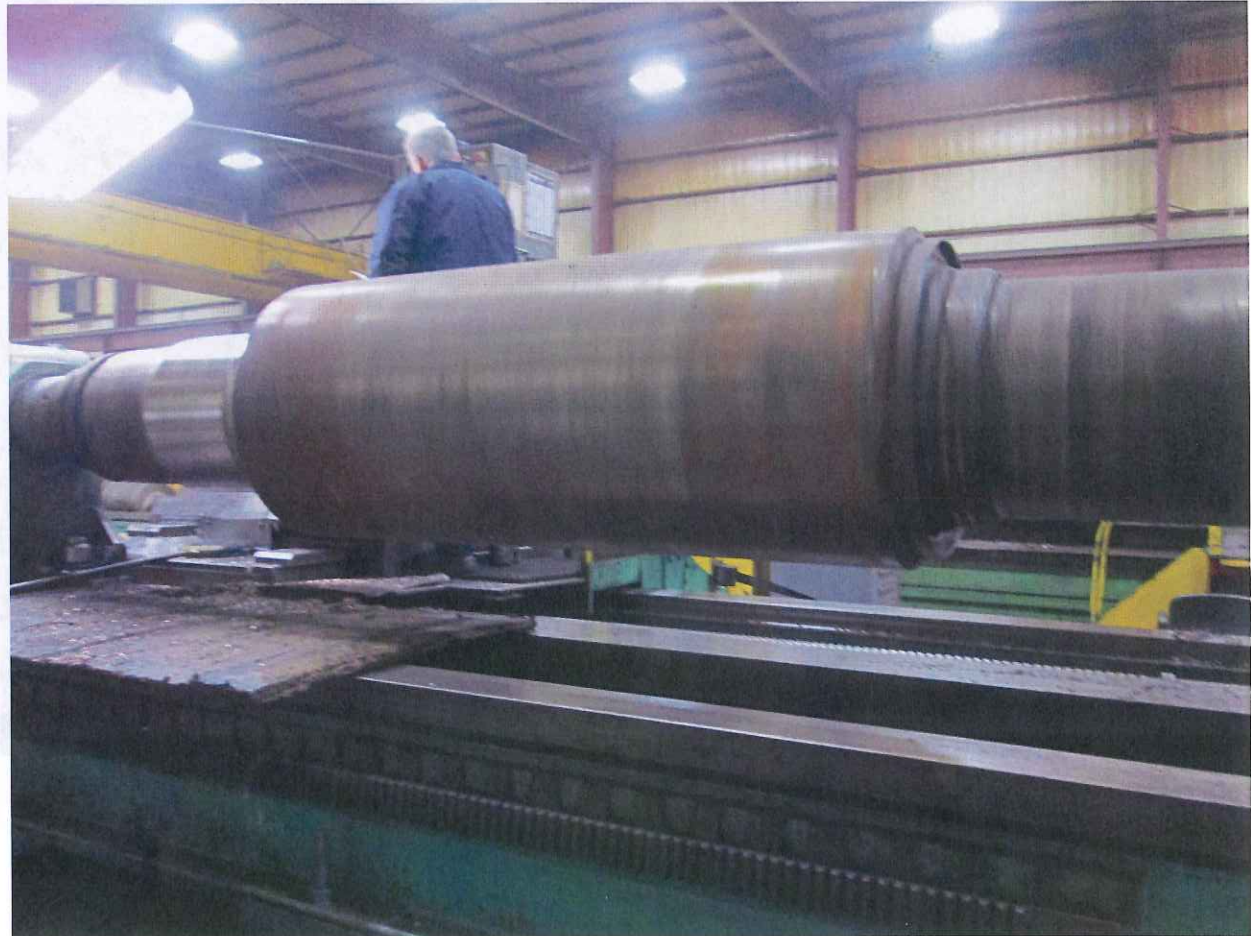
PHOTOGRAPH: 3

Leveler Rolls-grinding of small parts

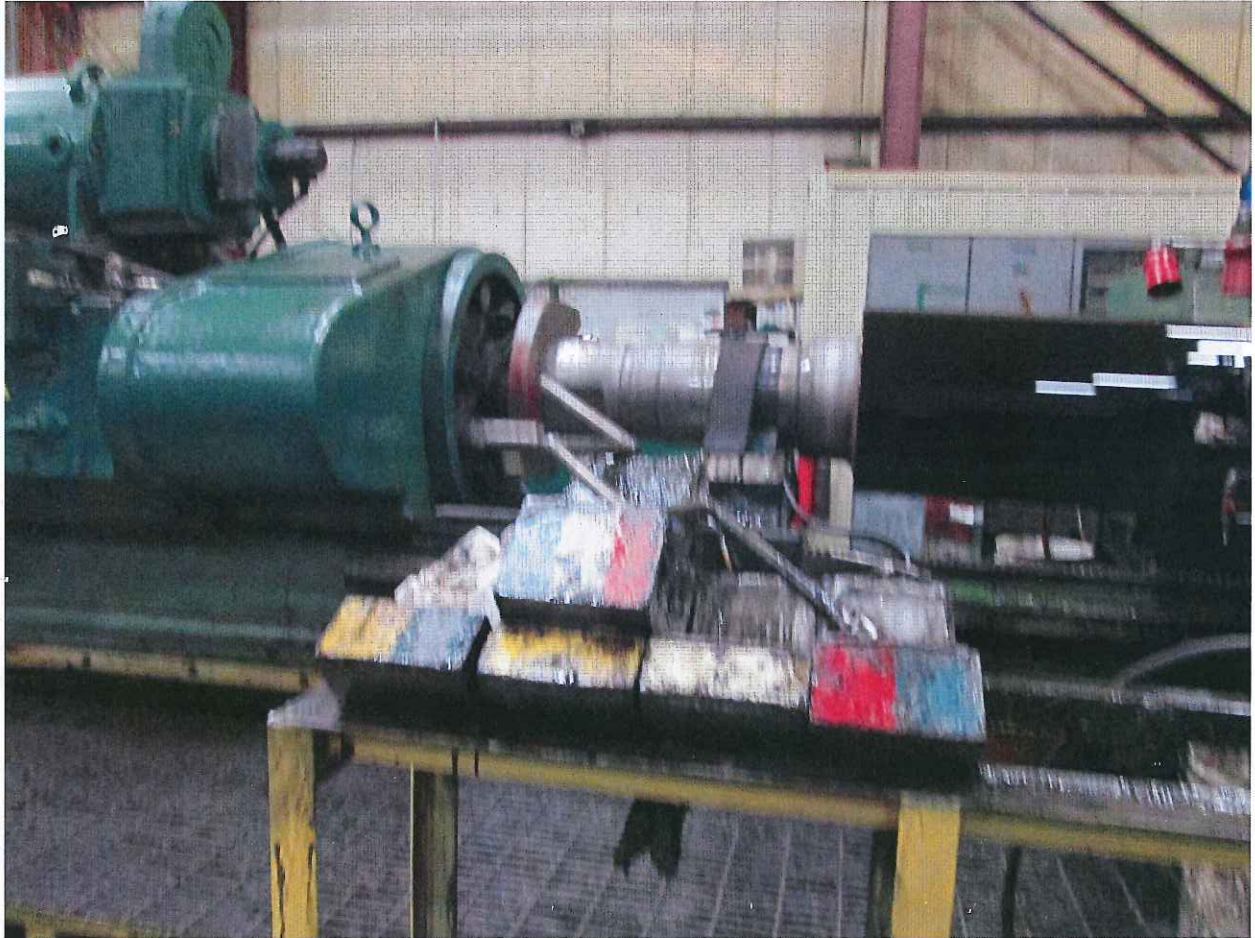
PHOTOGRAPH: 6
NAME OF PHOTOGRAPHER: Sheila Burrus
DATE OF PHOTOGRAPH: November 16, 2015
LOCATION OF PHOTOGRAPH: Sandblasting Area
SITE LOCATION: 1079 Industry Drive Lot 1
Chesterton, Indiana 46304
INSTALLATION NAME: Herr Voss Stamco
INSTALLATION I.D. # INR 000 105 213

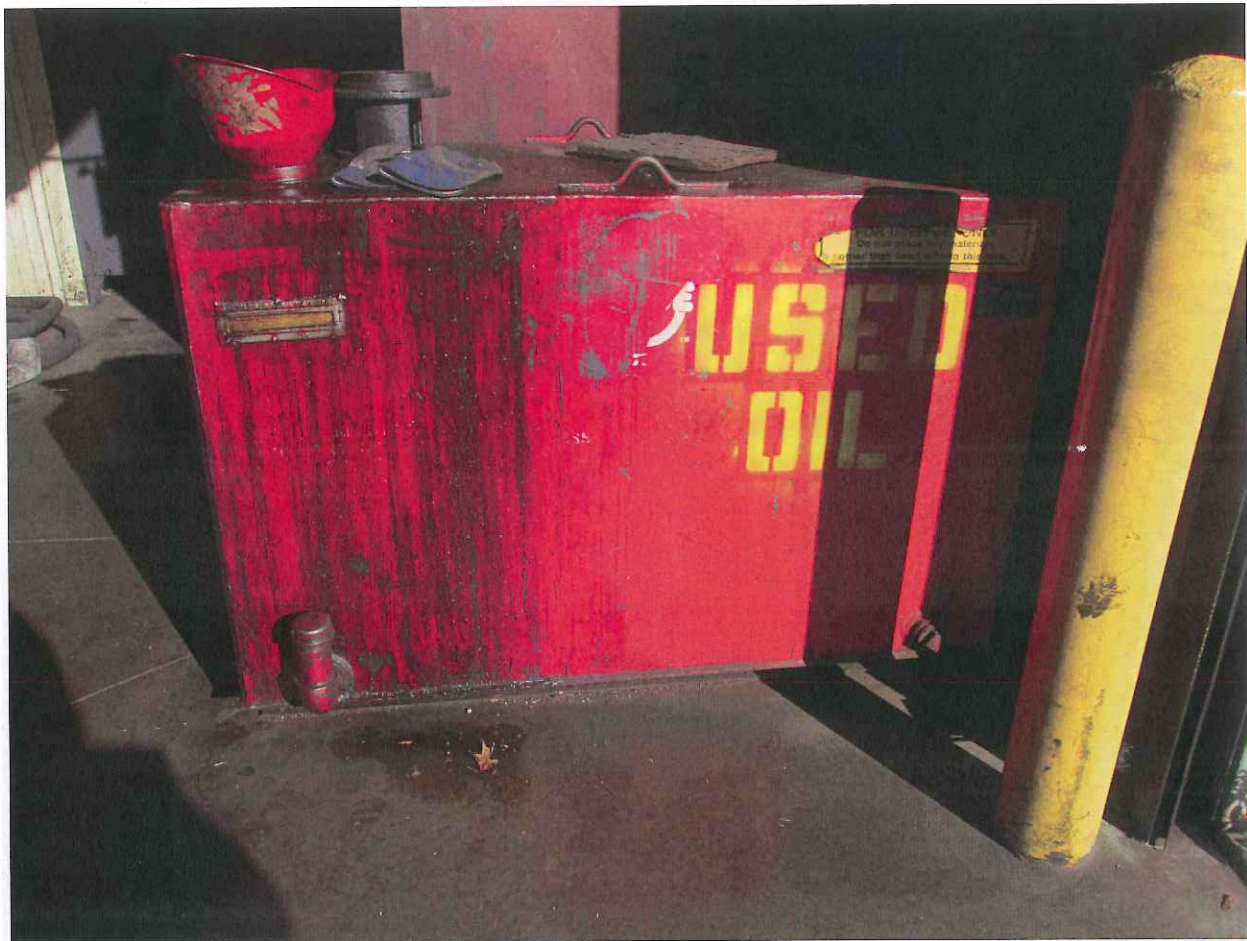
PHOTOGRAPH: 7

Truck Bay Area

labeled 300-gallon used oil tank

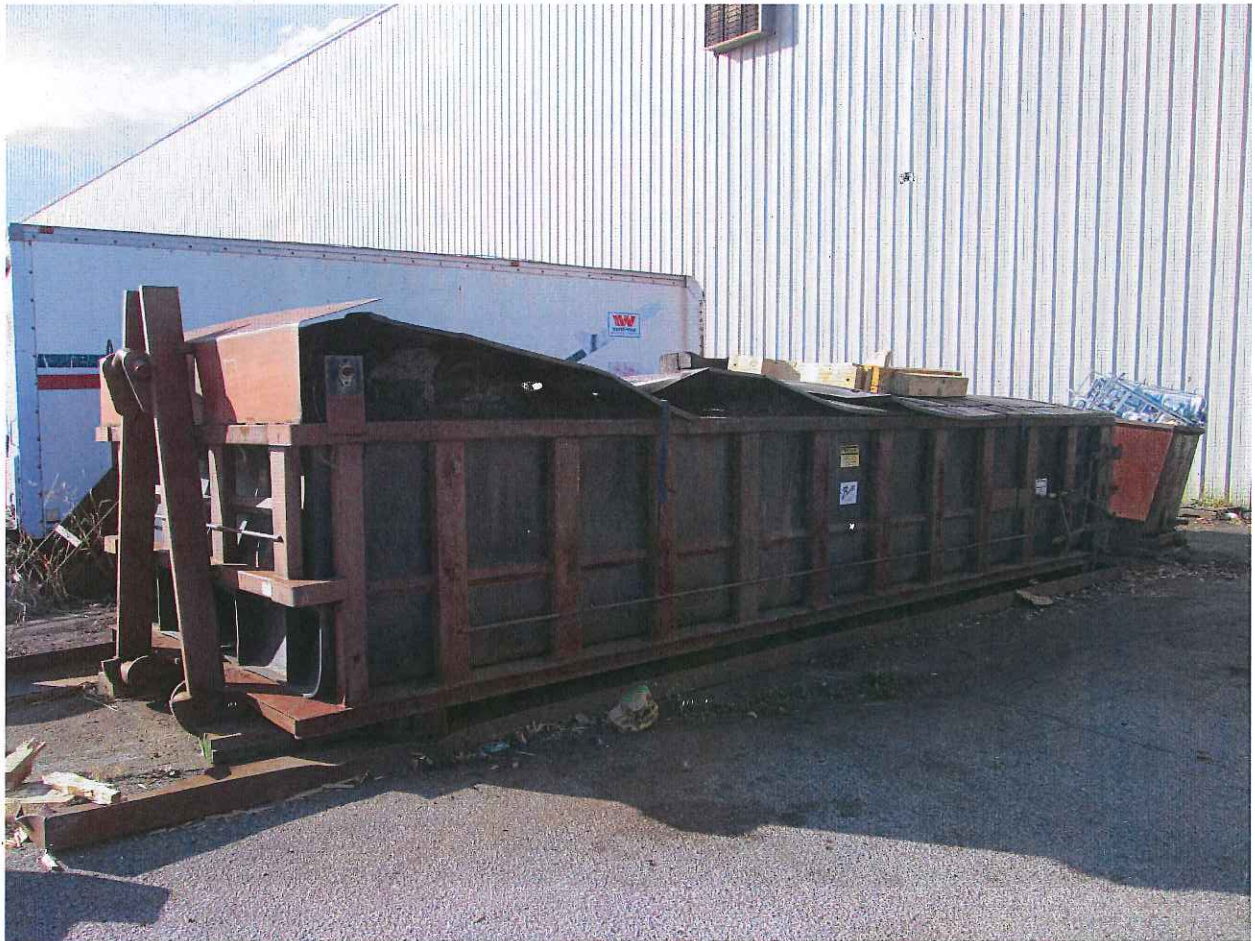
Herr Voss Stamco generates a special waste from grinding mill rolls that comes from its customers for reconditioning. The metal grinding swarf from the grinding operation is collected into hoppers and then transferred into a 30 yard roll off dumpster located outdoors.

PHOTOGRAPH: 8
NAME OF PHOTOGRAPHER: Sheila Burrus
DATE OF PHOTOGRAPH: November 16, 2015
LOCATION OF PHOTOGRAPH: outdoor
SCENE BEING PHOTOGRAPHED: 30-yard roll-off box for grinding swarf
SITE LOCATION: 1079 Industry Drive Lot 1
Chesterton, Indiana 46304
INSTALLATION NAME: Herr Voss Stamco
INSTALLATION I.D. # INR 000 105 213
